DIFFICULTIES IN DETERMINING THE CAUSE OF REAL-WORLD CRASH INJURIES: A CASE STUDY OF A NASS INVESTIGATION

Raul A. Arbelaez

Insurance Institute for Highway Safety

Paper No. 122

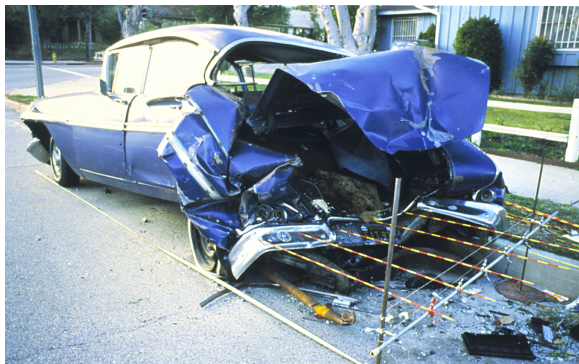
The direct damage measured on the Bel Air by the NASS investigators was 137 cm from its left side, but the field photographs show that the length of direct damage extended from the left side of the vehicle to a point just beyond the C4 measurement location (Figure 1). Because there was no exemplar Bel Air available prior to the first crash test, an approximation was made for this direct damage length. The estimated length of 118 cm was used as the overlap for the first test. When the rear of the Bel Air was measured prior to the second test, the direct damage length was found to be closer to 124.5 cm from the left side of the vehicle.

Figure 1. Photograph of rear-struck 1958 Chevrolet Bel Air from NASS case file (79-021A).

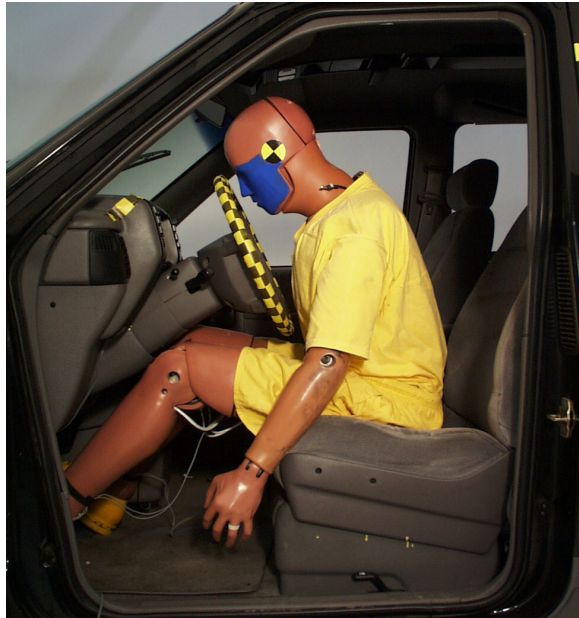
Two static airbag deployment tests were conducted in a 1991 Dodge Grand Caravan with a Hybrid III 50th percentile dummy positioned over the airbag. In the first airbag test (KA00001), the dummy was positioned in the driver seat, then the upper torso was rotated fully forward. This setup was used to represent how the NASS driver might have been positioned if he was slumped over the steering wheel. The goal of the second airbag test (KA00002) was to fully expose the chest to the airbag deployment force by placing it as close to the airbag module as possible. Previous research has shown that the highest dummy injury values are produced when the chest is placed directly on the airbag module (Horsch et al., 1990; Melvin et al., 1993). The second airbag test was considered the worst-case airbag loading scenario for the NASS driver.

Figure 2. In the first test (KA00001), the dummy was seated in a normal position, and the upper body was pushed forward.

instrumentation data were collected during the tests. Figures 2 and 3 show the dummy's position with respect to the airbag module in these tests. Table 2 summarizes the dummy clearance measurement in each test.

Results of the static airbag tests show that when the dummy was in the slumped position, there was very minor risk of injury from the airbag alone. In the second airbag test, the chest-on-module position produced higher chest injury measures, including a

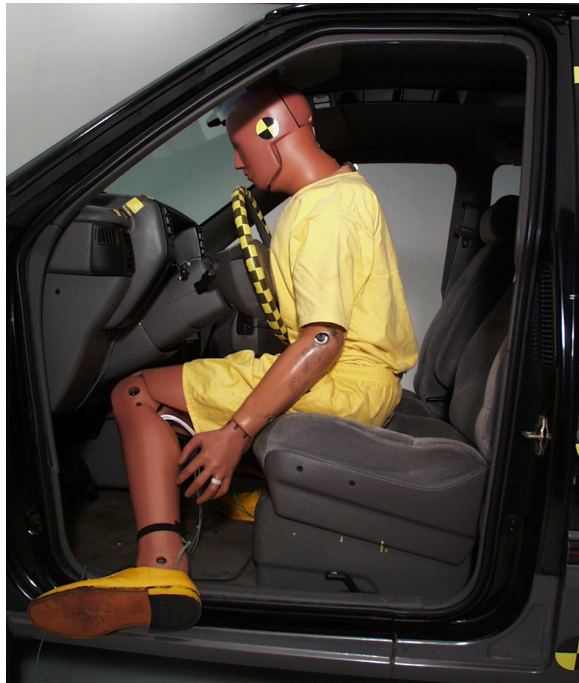
Figure 3. In the second test (KA00002), the dummy was pushed forward in the seat until the chest was directly on the airbag module.

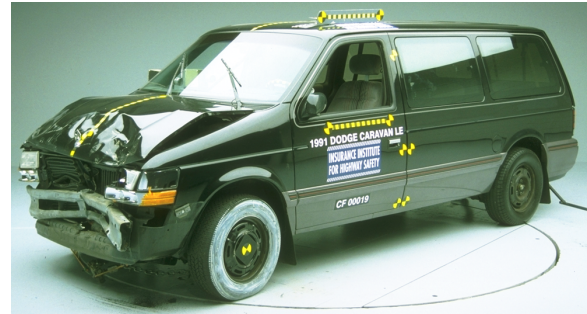
The actual impact velocity (64.0 km/h) for the second test resulted in an increased delta V of 37.1 km/h. Unexpectedly, the Grand Caravan crush pattern in this test was much different than that observed in both the first test and the NASS case. Figure 6 shows that although the crush on the right side of the Grand Caravan increased from the Caravan, it was approximately 10 cm less than the NASS Grand Caravan, and the maximum crush location was shifted from the far right side to the center of the vehicle. The postcrash contour of the Bel Air in the second test shows that its rear structure sustained approximately 50 cm less crush than the NASS Bel Air (Figure 5). This damage differed from the NASS Bel Air in that override of the rear frame rails was not observed (Figure 8). Postcrash views of the Grand Caravan and Bel Air used in the second test are shown in Figures 7 and 8. Figure 9 shows the NASS Bel Air for comparison purposes.

Figure 7. Postcrash view of 1991 Dodge Grand Caravan used in second crash test (CF00019)

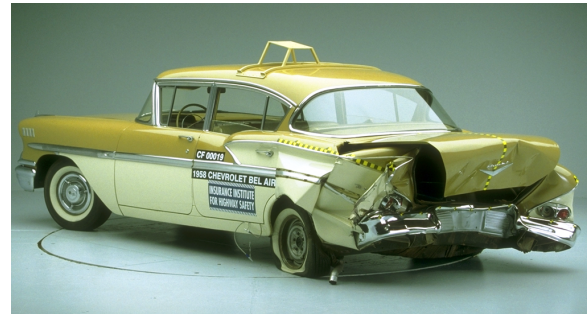
Figure 8. Postcrash view of 1958 Chevrolet Bel Air used in second crash test (CF00019).

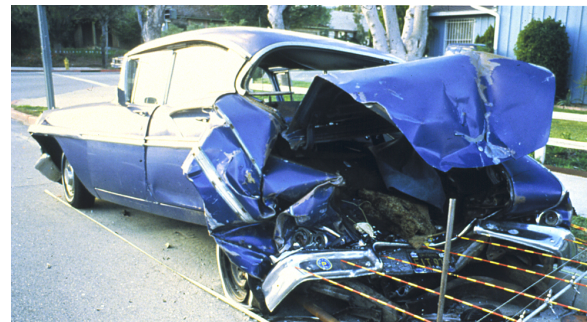
Figure 9. Photograph of rear-struck 1958 Chevrolet Bel Air from NASS case file (79-021A).

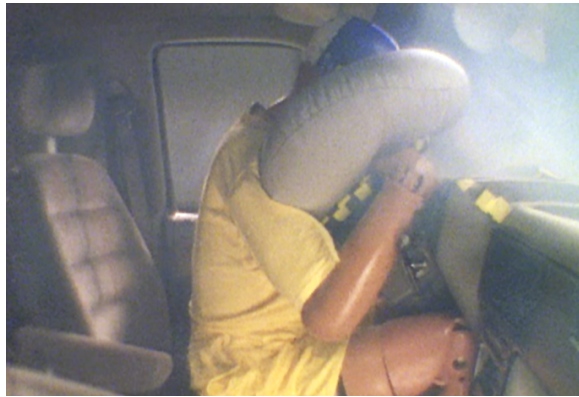
Dummy Kinematics Analysis of the high-speed film taken from onboard cameras showed that airbag deployment in both tests occurred at approximately the same time (28-30 ms into the crash). In both tests, the airbag made contact with the chest prior to full inflation, causing minor increases in chest sternum displacement and acceleration. The dummy then traveled forward into the deploying airbag, where the chest began to load the bottom of the airbag. As forward travel continued, the dummy's face began to load the airbag, and the steering column started to tilt upward. Upward movement of the steering column caused the bottom of the rim to move up toward the chest, and as the dummy continued to move forward, contact between

the lower rim and the dummy's chest occurred. Figure 10 shows the contact between the shifted steering column and the dummy's chest in the second test. Contact with the steering wheel rim occurred at 140 ms in the first test and at 110 ms in the second test. After contacting the rim, the dummy moved forward and slightly upward before rebounding back into the seat. Table 3 summarizes the timing of the airbag deployment and dummy contacts in each test.

Figure 10. Dummy chest-to-steering wheel contact observed in the first crash test (CF00018). Similar steering wheel movement and chest contact was observed in the second crash test (CF00019).

The chest injuries that resulted from contact with the lower steering wheel rim were observed in both crash tests conducted at two different impact velocities. The deflection-based chest injuries observed in these tests, which were underestimated due to off-axis loading, correspond to a 40-50 percent risk of an AIS 3+ thoracic injury (Mertz et al., 1991). These injuries had minimal dependence on airbag timing because the tilting of the steering wheel rim produced a situation in which the airbag was not in an optimum position to protect the occupant. In a previous study, Yoganandan et al. (1993) conducted sled tests in which an unbelted occupant’s forward motion was restrained by a knee bolster and an airbag; these restraint conditions were similar to the ones employed in the current study. In the sled tests, thoracic contact with the lower steering wheel rim that was observed produced primarily lower rib fractures (AIS 2-4) in the human cadaveric subjects. Although there were no observed fractures to the sternum in these tests, several did occur to the 4th and 5th thoracic ribs. These ribs are vertically aligned with the bottom of the heart, which means that the rim loading could have been the injury-causing mechanism in the NASS case.

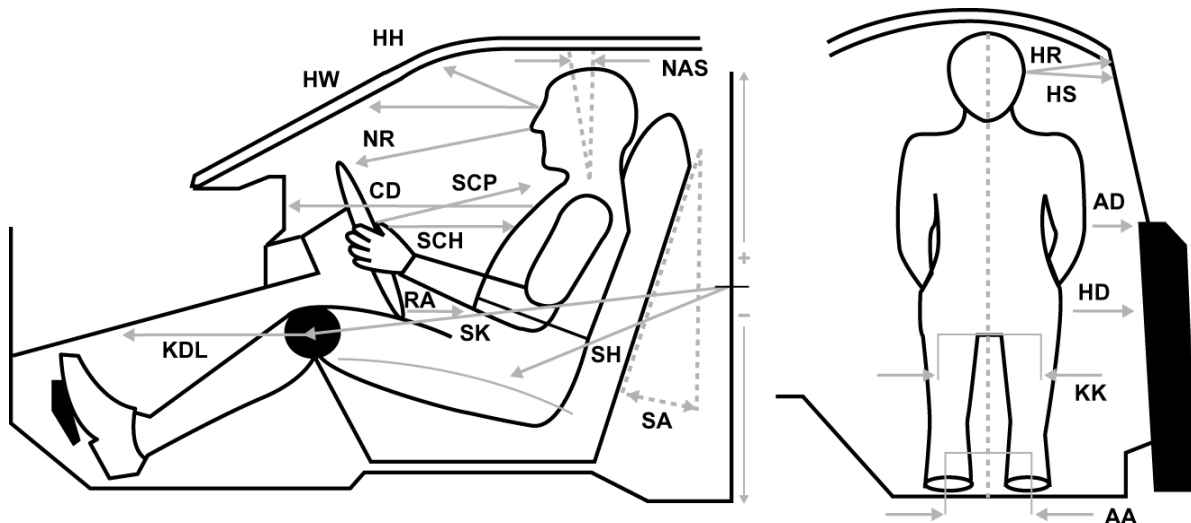
Dummy Clearance Measurements for Second Crash Test

Test number:	CF00019
Vehicle make/model:	Dodge Grand Caravan
Vehicle model year:	1991
Seat type:	Electrically adjusted bucket seat (fore/aft and seat back angle)
Test Position	
Seat back information:	Adjusted to accommodate dummy torso recline position of 10°
Seat cushion:	1.2 cm from rear track position
Steering column adjustment:	Set to midpoint of tilt range

* These measurements were made in a vertical plane containing the striker and parallel to the driver door sill.
